# A New Method For Assessing Coronal Alignment of The Tibial Component in Total Knee Arthroplasty With an Intramedullary Rod

Aykut Sigirci

## Abstract

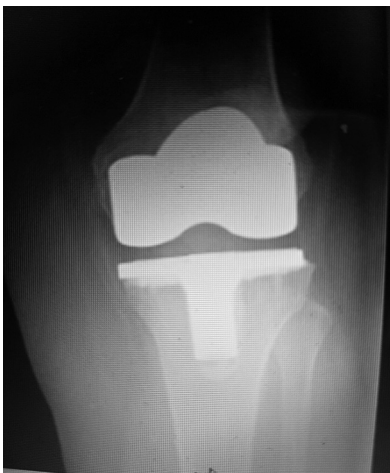
**Figure 1:** Total knee arthroplasty in varus alignment

Total knee arthroplasty (TKA) is the primary operative treatment for advanced knee osteoarthritis. Proper positioning of the femoral and tibial components is very important because malpositioning can cause undesirable results, such as implant loosening and persistent pain, and can compromise implant survival [Figures 1 and 2].<sup>[1]</sup> Proper coronal, sagittal, and rotational alignments of both the femoral and tibial components are vital, but the coronal alignment of the tibia is the most important.<sup>[2-5]</sup> In many clinics, expensive navigation systems are used to minimize errors in TKA operations.

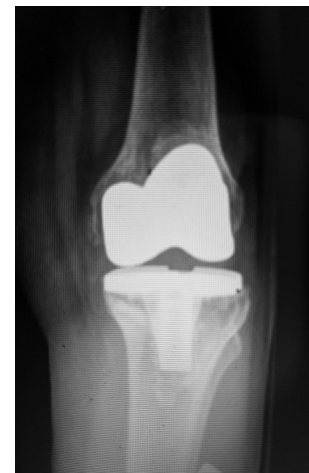
**Figure 2:** Collapse of the tibial plateau in the same knee
